Inspection Report

Minerals Regulatory Program

Mine Name: Black Rock Quarry	Permit Number: M/027/0088
Operator Name: Stone Resources LLC	Inspection Date: July 19, 2016
Inspector(s): Peter Brinton	Time: afternoon
Other Participants: none	Mine Status: Reclaimed

Inspection Purpose: Evaluate reclamation for full site and bond release

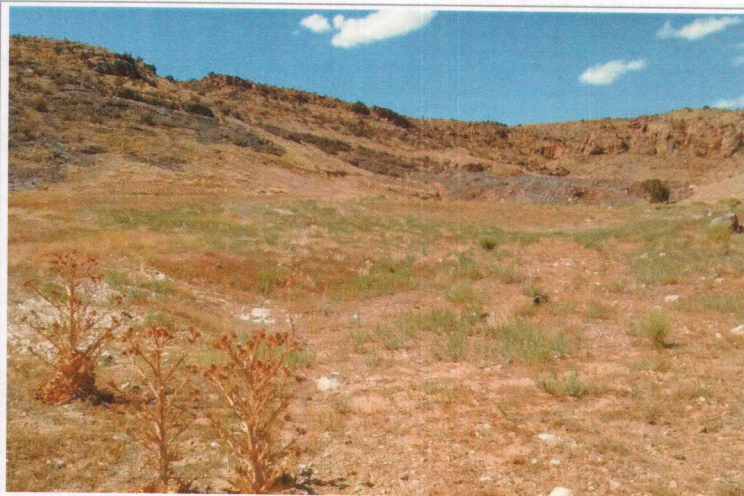
View from below the former processing area, with Scotch thistle.

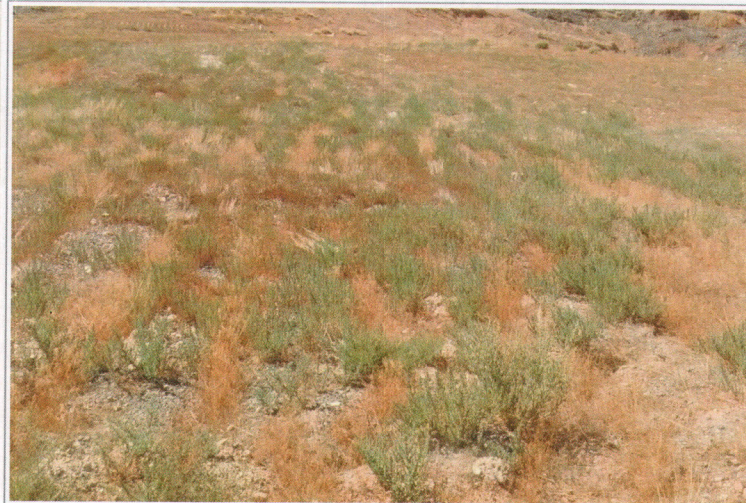
Halogeton and cheatgrass growth on ripped areas below the processing area.

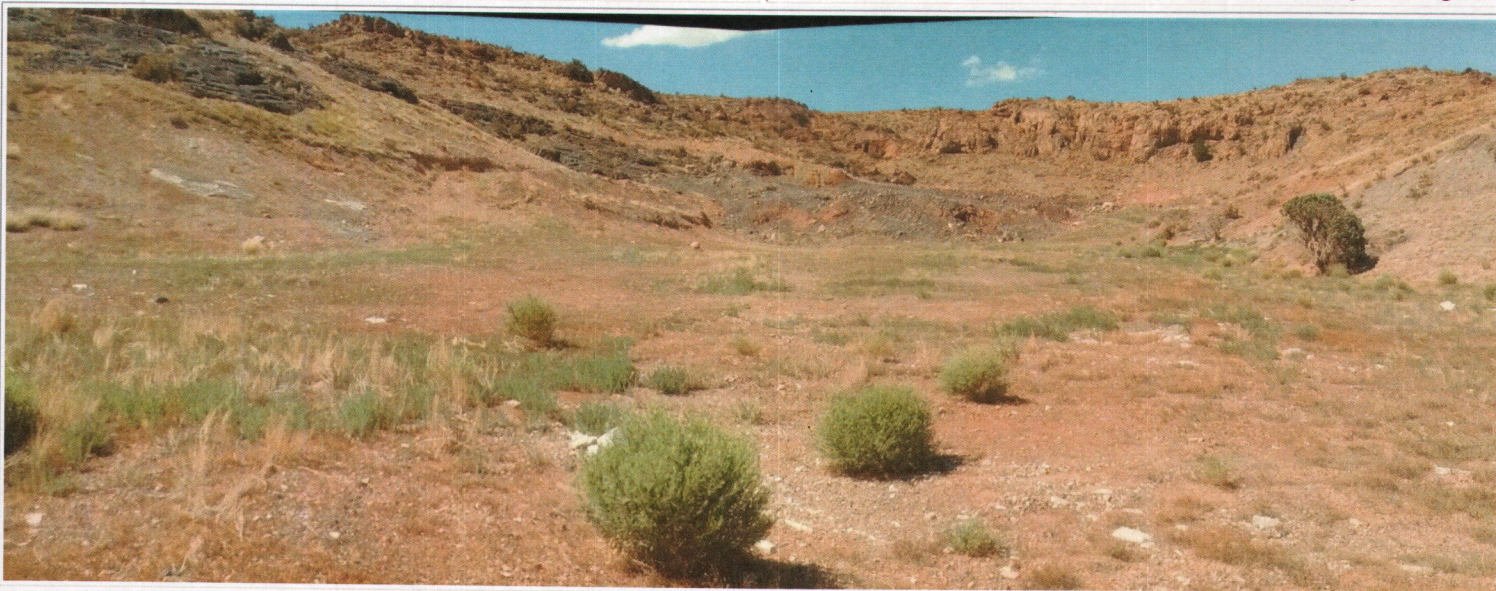
View of regraded processing and quarry areas. Some bare areas are visible.

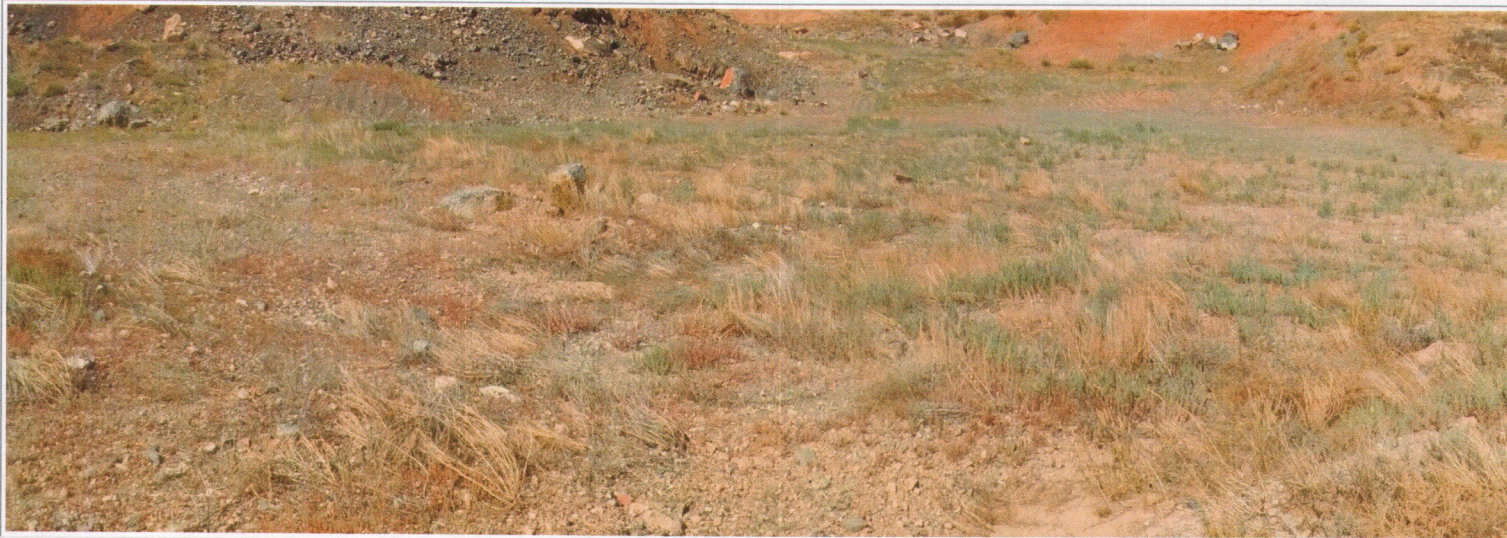
Mixture of halogetan skeletons (tan) and live halogetan plants at the foot of the mine slope area, with little or no seeded species.

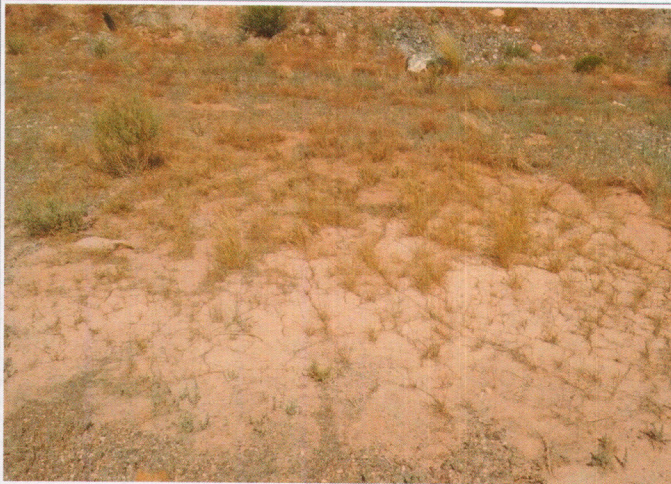
Patch of crested wheatgrass where water has ponded.

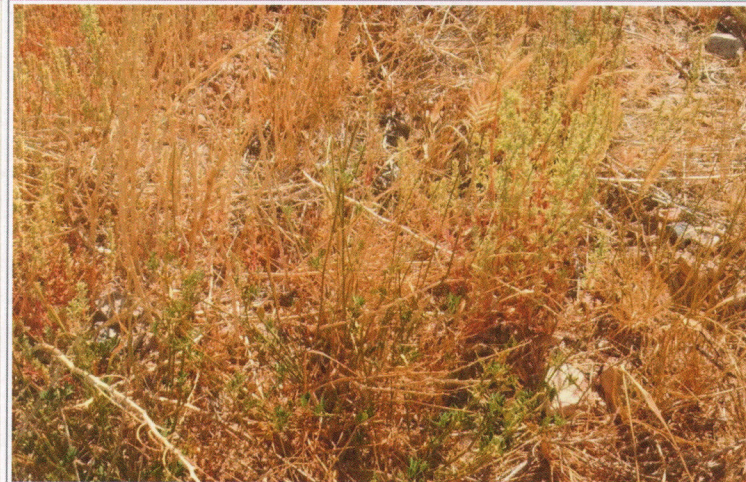
Mixture of crested wheatgrass and halogetan.
